The Metallurgy of Honduras Provincial Reales

by John Lorenzo

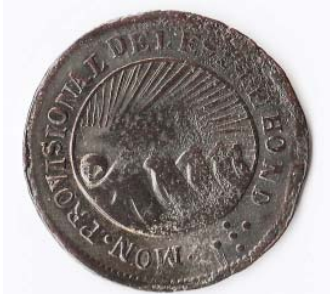
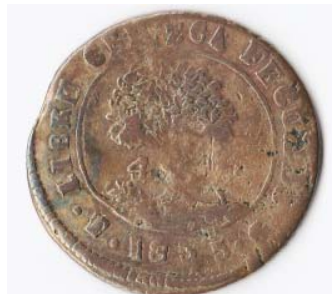
Coin # 1: 1851

Date of Issue	KM# Denom.	Diameter/ Weight	Silvering Visible?	Cu	Pb	Ag	S	Fe	Hg	Comments (See Note 1)
1. 1851	20-a, 4R	29.6 mm ; 7.1 gms.	Yes	96.8	ND	1.63	ND	0.36	ND	Iron probably as an ore contaminant. High copper with trace silvering on this early piece. We generally do not see silvering on later pieces. The silvering does not appear to be of a mercuric silvering nature? More testing needed

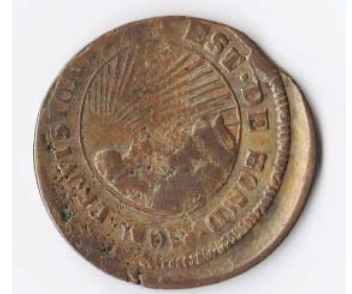
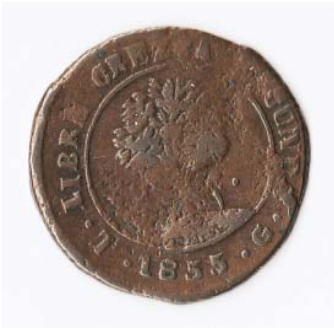
Coin # 2 - 1855

2. 1855	20-d, 4R	29.2 mm; 8.2 gms.	No	97.0	ND	ND	2.14	0.87	ND	VF/XF grade. The grade of specimen #1 was AU which may account for traces of surface silvering be present or not in my opinion.

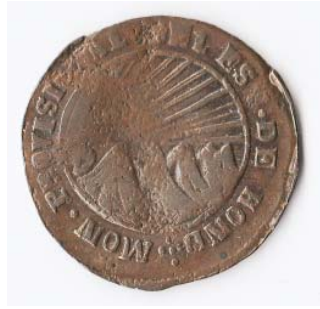
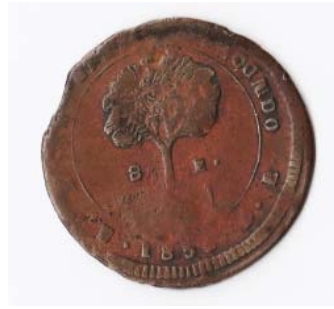
Coin # 3: 1855

3. 1855	20-d, 4R	28.9 mm; 6.4 gms.	No	98.9	ND	ND	0.79	0.21	ND	These Honduras pieces have high sulfur which is indicative of a poor smelting operation of Cu.

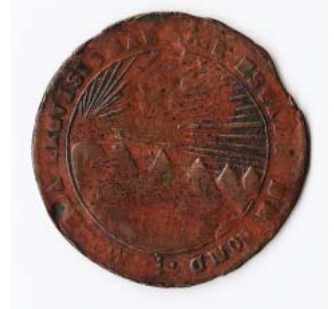
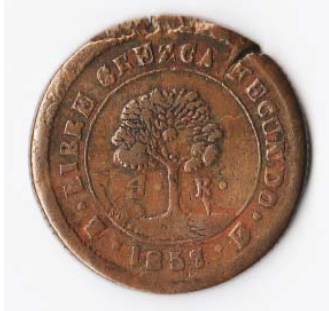
Coin # 4: 1856

4. 1856	21-a, 8R	39.11 mm; 11.0 g	No	98.4	ND	ND	1.46	ND	ND	Thinner piece and low weight. No lead found. Again we see the high sulfur confirming a poor copper annealing operation.

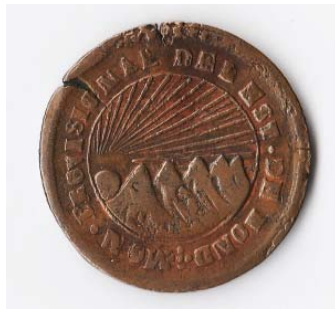
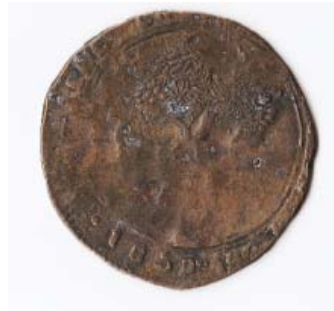
Coin #5: 1857

5. 1857	20d, 4R	31.4 mm; 13.8 g	Yes	81.16	ND	17.2	0.56	ND	ND	This surface analysis as we see was run in triplicate. We see a high silver area and lead being introduced. Perhaps silver was used throughout and this specimen is XF/AU. The silver may retain obviously on higher preserved pieces. The lead used for easier metallurgy to reduce the high melting point of copper.

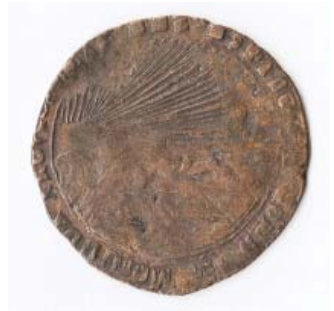
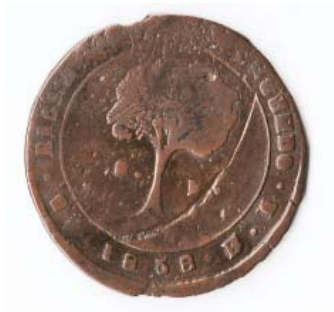
Coin # 6: 1858

99.1	0.9	ND	ND	ND	ND	
				97.9	1.81	ND	ND	0.22	ND	
6. 1858	21-a, 8R	34.75mm; 9.14 g	No	90.6	7.3	ND	ND	1.95	ND	The previous owner thought maybe a forgery of the period with an 8R weight of only 9.14 grams. High lead seen in a grayish surface area intentionally scanned. The lead is anything but homogenous in these alloys in my opinion.

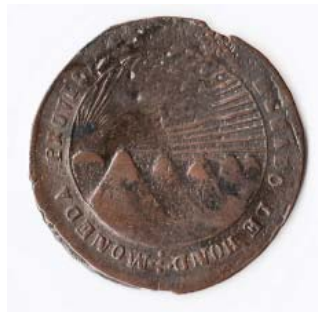
Coin # 7: 1858

7. 1858	21-a, 8R	38.2 mm, 13.8 g	No	92.5	ND	ND	4.1	3.3	ND	No lead seen here but the lead is not uniform in these alloys so more work is needed on when lead was introduced to ease the copper metallurgy process and if silver occurred throughout these pieces from 1851-1858? Iron and sulfur are universal contaminants.
